# ANNUAL REPORT

# ARCHÆOLOGICAL DEPARTMENT

SOUTHERN CIRCLE, MADRAS

1914-1915

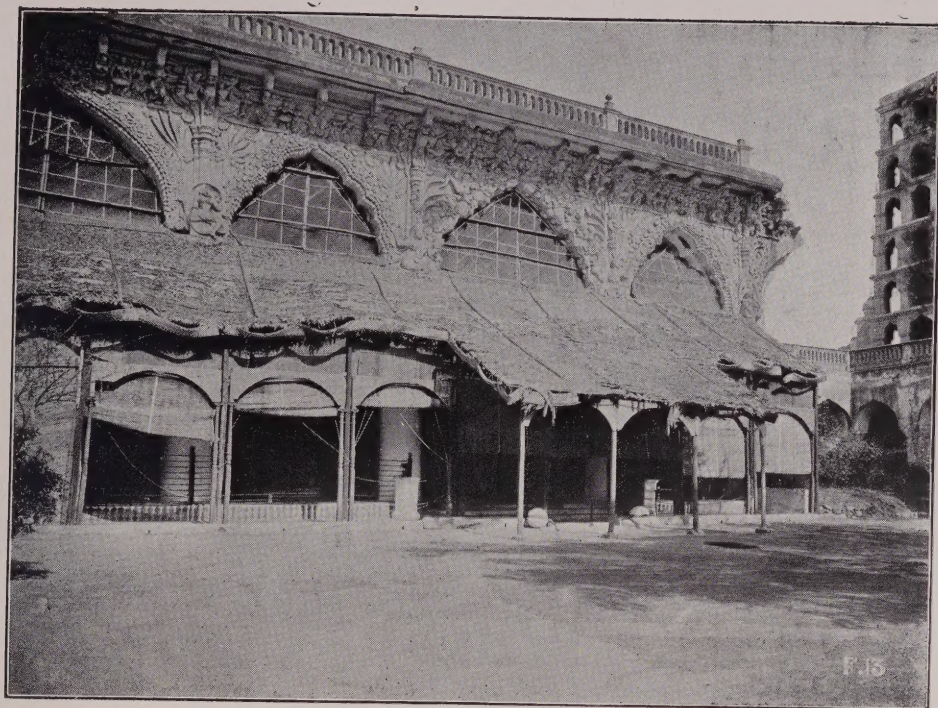
PLATE XVI (a)

The Nayak's Durbar Hall, Tanjore Palace.  
(Before Repairs.)

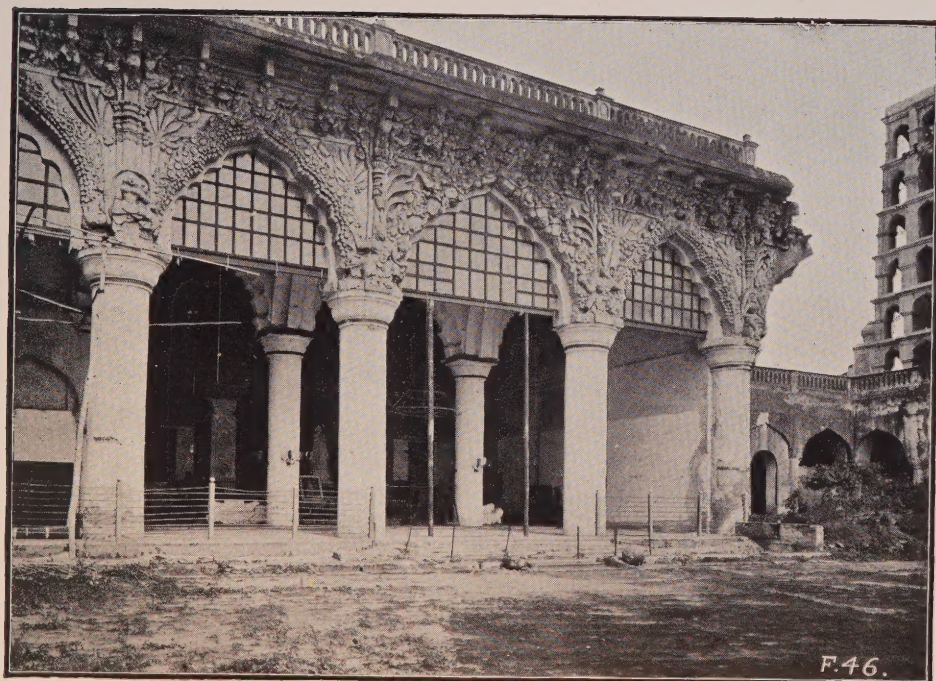
PLATE XVI (b)

The Nayak's Durbar Hall, Tanjore Palace.  
(After Repairs.)
